CITY OF MENASHA
Board of Public Works Meeting
Third Floor Council Chambers, 140 Main St., Menasha
February 5, 2007

RE: Traffic Study Report – Southfield Drive and Deer Haven Drive

Traffic Study – Southfield Drive @ Deer Haven Drive

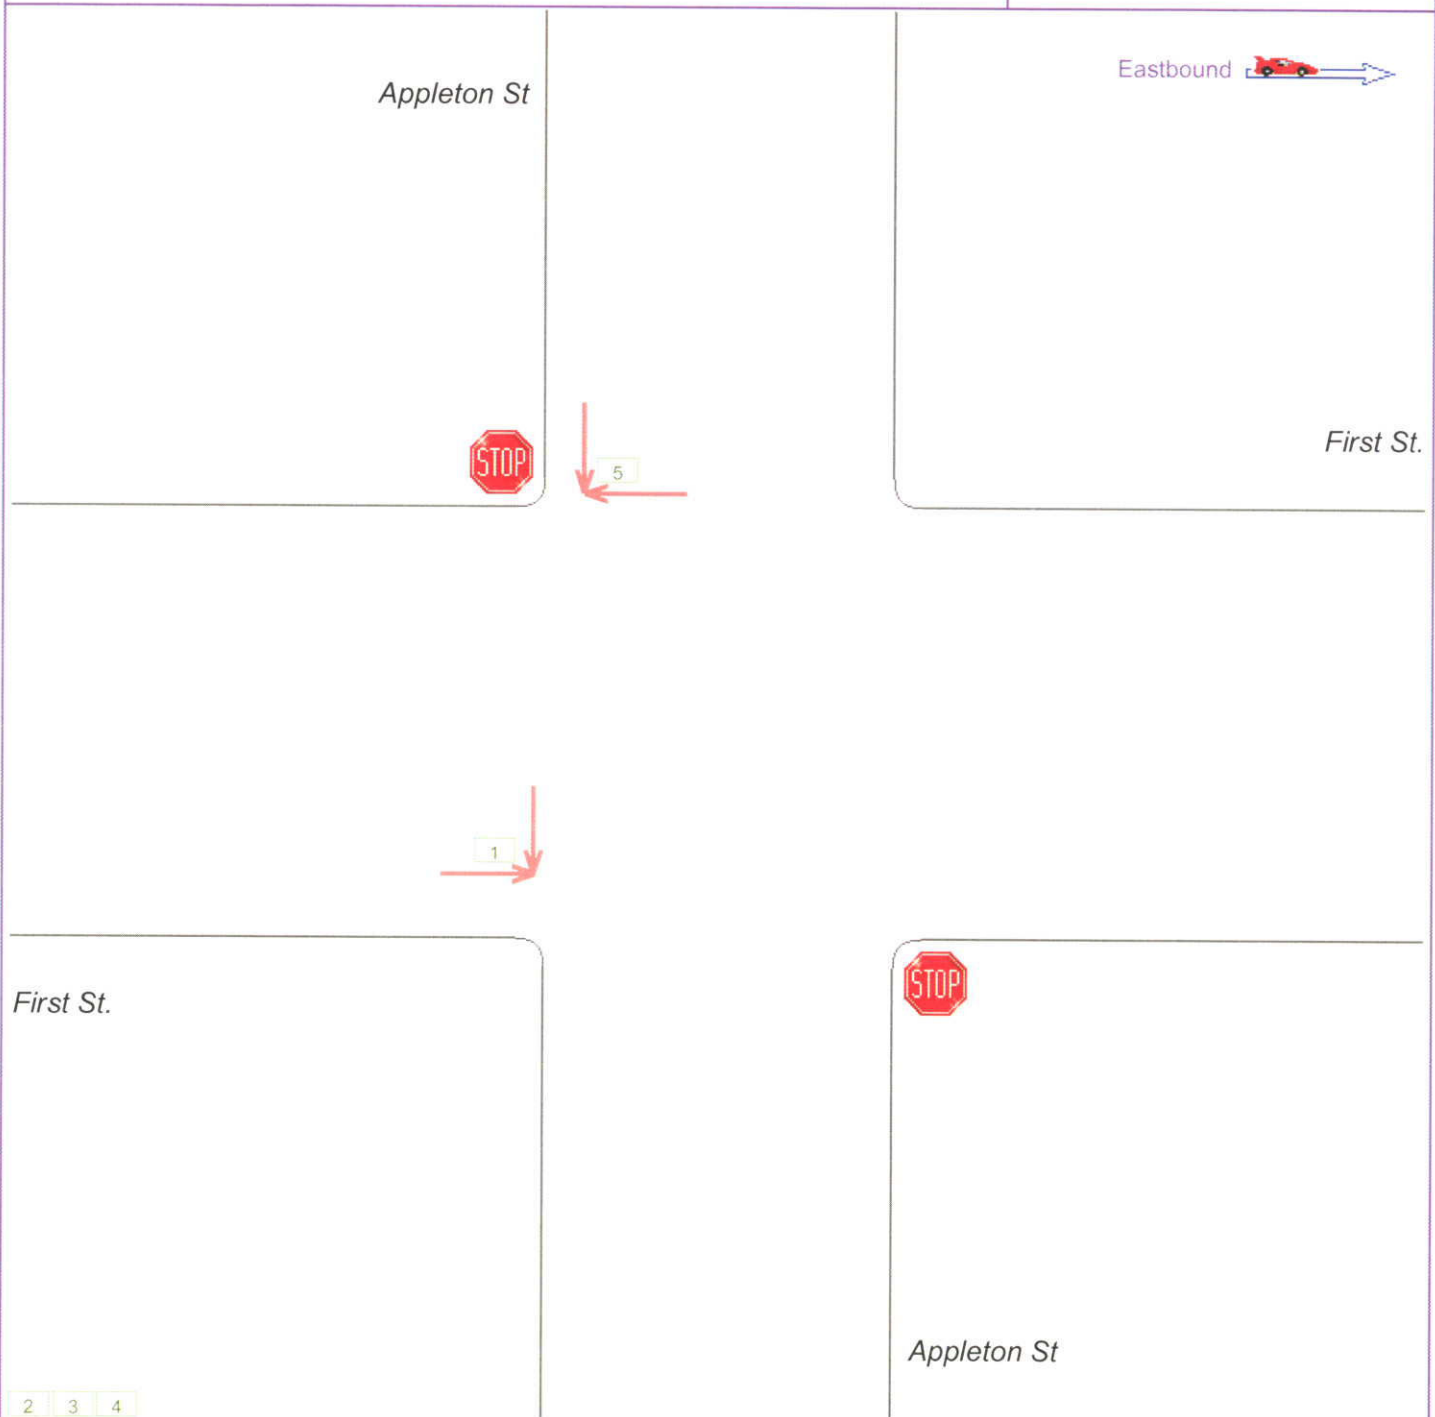
MUNICIPALITY: <u>Menasha</u>	COUNTY: <u>Winnebago</u>	FILE: <u>first_appleton</u>
INTERSECTION: <u>First St.</u>		CASE #: _____
PERIOD: <u>0</u> YEARS <u>0</u> MONTHS	FROM _____ TO _____	BY: <u>cr</u> DATE: <u>1/8/2007</u>

SYMBOLS				MANNER OF COLLISION
